Distress Due to Sun Camber in a Long-Span Roof of a Parking Garage

by Mark Fintel and S. K. Ghosh

Distress in a 9-story cast-in-place concrete parking garage is described. A detailed account is given of field observations, measurements, and computations leading to a definite diagnosis for the distress. A repair procedure that accommodates unavoidable movements of the structure is outlined.

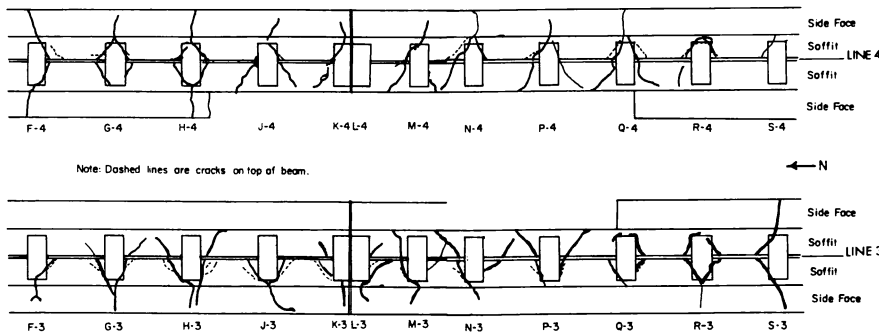
The 18 x 24 in. (457 x 610 mm) interior (split) supporting beams of the sloped east and west bays of the uppermost level showed cracks generally on all four faces, (Fig. 2). These split beams on column lines 3 and 4 extend over 10 bays between lines F and S. The diagonal cracking at the beam ends ranged from slight to

Fig. 2 — Cracks on faces of sloped split beams on lines 3 and 4 of level 8-9 (not to scale).

- The cracks shown in Fig. 2 on the tops and on the soffits of the inclined beams are in the same direction, indicating that horizontal forces due to post-tensioning and creep from post-tensioning pull on the beams horizontally toward the slab span.
- The direct solar radiation on all three roof bays causes a thermal gradient in the 4-in. (102-mm) thick slabs and in the slab beams, which results in an upward deflection (sun camber) of the 60 ft (18.3 m) span, and a consequent rotation of supports.
- The supporting beams of the sloped side bay roofs (on lines 3 and 4) are restrained against rotation and against horizontal shortening by short, rigid columns below and above (Fig. 5).
- The supporting beams of the horizontal middle bay roof have some rotational freedom since they are restrained against rotation only by the columns below (Fig. 5).

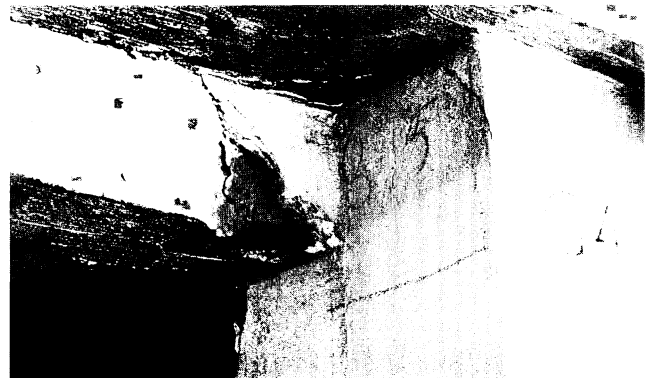
severe (Figs. 3 and 4). The diagonal cracks were patched over the years with different materials (apparently in different operations at various times). The repairs did not prevent repeated cracking, although some of the patching material seemed quite flexible.

Fig. 4 — Cracks at column G4.

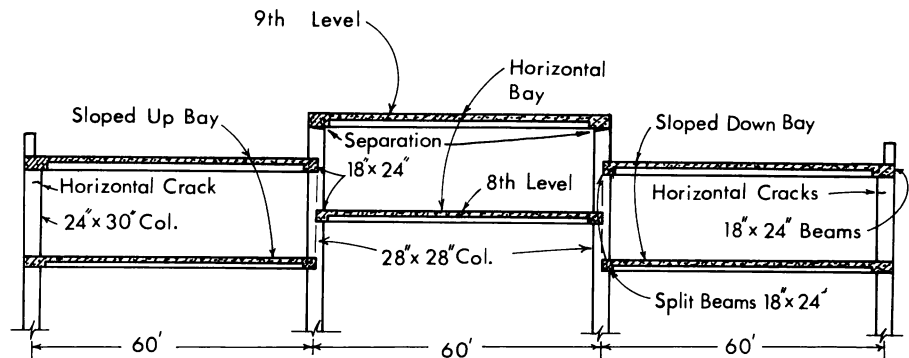
At the uppermost horizontal central bay, a line of separation (Fig. 5) at the interior interface between beams and columns was observed in many cases, with no distress, however, in the beams. This indicated that the absence of a strong restraint (no column above) allowed these beams to rotate without suffering torsional cracks. At the corresponding exterior (east and west) ends of the sloped bays, there were horizontal cracks observed on the interior faces of the exterior columns about 15 to 20 in. (381 to 508 mm) under the beams. The depth of the cracks reached only about 1/4 of the

column depth (Fig. 5). Three of these cracks measured 5, 6, and 10 thousandths of an inch (0.127, 0.152 and 0.254 mm) wide in the late afternoon of April 12 (air temperature 75F [23.9C]) and half as wide the next morning (air temperature 60 F [15.6 C]).

Fig. 5 — Transverse section at top of structure (not to scale)

- The slab beams of the horizontal middle bay roof, having less rotational restraint, could rotate upward at the supports and cause a cracked separation at the interface between columns and beams (Fig. 5). Also, the absence of columns above permitted some inward movement of the column tops caused by elastic and creep shortening of the post-tensioned slabs; thus the beams did not crack diagonally.

- The interior beams of the sloped side bay roofs, restrained against rotation above and below by the relatively large 28 x 28 in. (711 x 711 mm) short columns (say half story high), cracked because of the addition of torsional stresses caused by upward thermal slab deflections to the previously high vertical and horizontal shear stresses.
- The relatively large exterior beams of the sloped roof bays were not restrained by columns above. They rotated together with the long-span slab bowed up by the sun, and induced horizontal cracks on the inside face of the columns about 15 in. (381 mm) under the beams (Fig. 5).

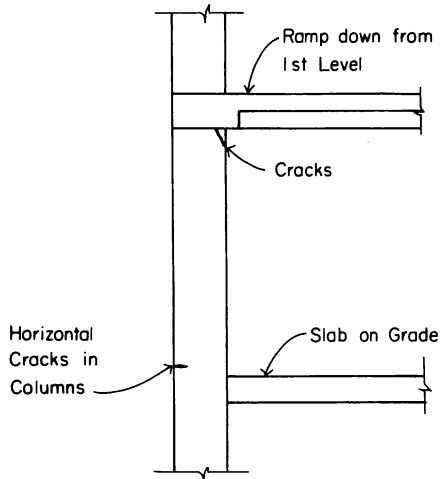
Fig. 9 — Section at ground level.

Several of the exterior beams of the ramp down from the first level (above the north-west entrance) had diagonal cracks at their soffits, some of them continued through the columns, causing tearing of the column corners under the beams. There were also horizontal

cracks on the outside faces of some of the columns above the slab on grade (Fig. 9).

The beam and column junctions had been repaired in recent years. Most repairs had subsequently failed. Examination indicated tensile forces directed inward and upward, supposedly caused by differential movements between the ground floor level and the first framed floor, due to:

Patches on distressed areas placed in May of 1984 had shown almost no signs of movement by November 1984. This indicated that the primary cause for the distress at this level was the winter shortening in the E-W direction of the entire 180-ft (54.9-m) wide garage relative to the ground.
