Preview of PCI's Japan Earthquake Reconnaissance Team Report

Richard Sause, Robert Frosch, S. K. Ghosh, Jason Lien,
Clay Naito, Larbi Sennour, and Toshi Yamanishi

The authors formed the PCI reconnaissance team that visited selected locations (**Fig. 1**) in Japan from June 27–30, 2011, following the Tohoku earthquake of March 11, 2011.

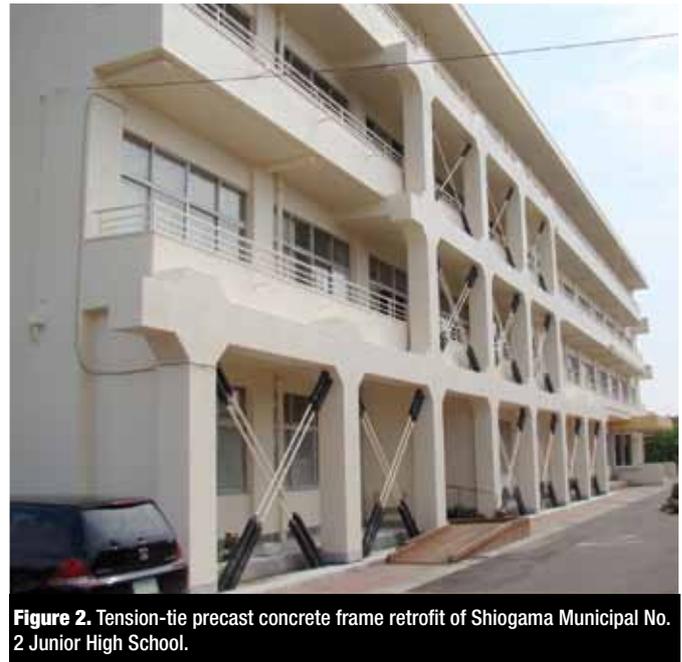
Figure 2. Tension-tie precast concrete frame retrofit of Shiogama Municipal No. 2 Junior High School.

The Shiogama Municipal No. 2 Junior High School (Fig. 2) was retrofitted in 2010 using an external precast concrete frame braced with tension ties. The existing cast-in-place concrete building was deficient in torsional resistance to earthquake loading. The north facade had stiff shear walls, while the south facade had moment frames, creating a torsional stiffness irregularity. The tension-tie-braced precast concrete frame increased the lateral stiffness along the south facade. The pieces included precast concrete columns anchored to the foundation using type II mechanical splices, architectural medallions on top of the columns, and drop beams between the medallions post-tensioned together on-site. To enhance the rigidity of the precast concrete frame, X-bracing with steel rods covered with plastic sleeves was used in the openings. Cast-in-place concrete diaphragms (Fig. 3) between the existing structure and precast concrete frame were used to transfer lateral shear forces to the external precast concrete frame. No damage to this structure was observed.

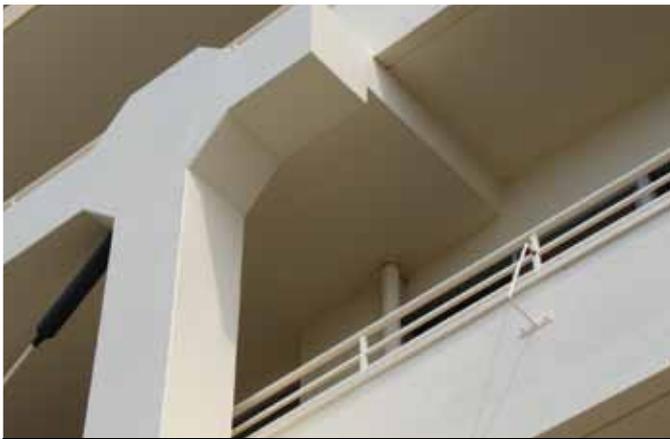
Figure 3. Cast-in-place concrete diaphragm of retrofit of Shiogama Municipal No. 2 Junior High School.

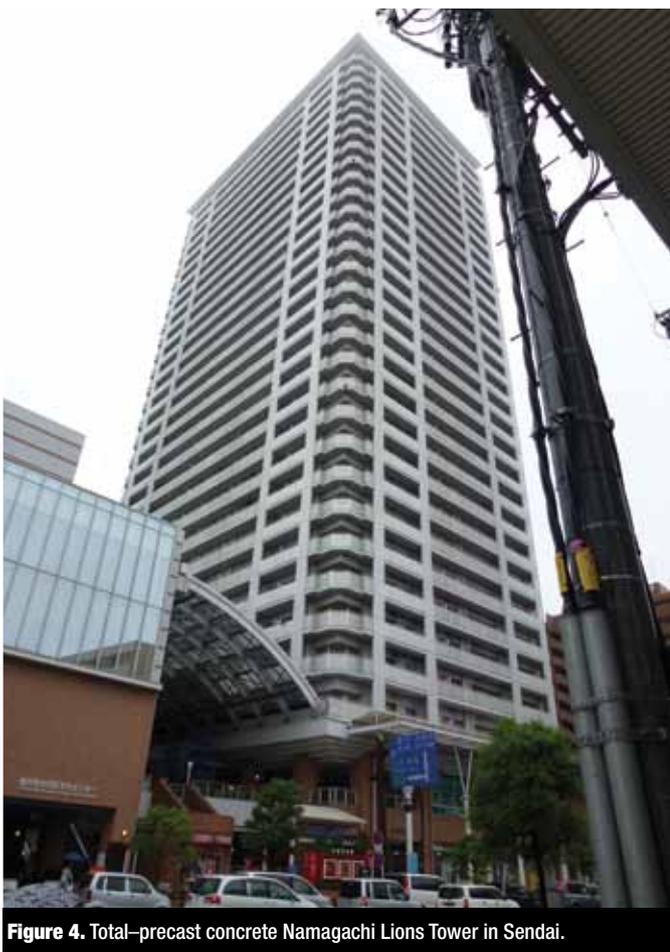
Figure 4. Total-precaster concrete Namagachi Lions Tower in Sendai.

The Namagachi Lions Tower (**Fig. 4**) in Sendai is a 29-story total-precaster concrete tower on a two-story, cast-in-place concrete podium. The structure was completed in 1999, and the lateral-force-resisting system consists of precast concrete moment-resisting frames. There was minor spalling near the base of three columns on the front of the building (**Fig. 5**). The only other visible damage was spalling of the underside of the slab (**Fig. 6**) at two opposite corners of the building, where two orthogonal beams that appeared to be unconnected came together. This damage did not appear to be significant, and the building appeared

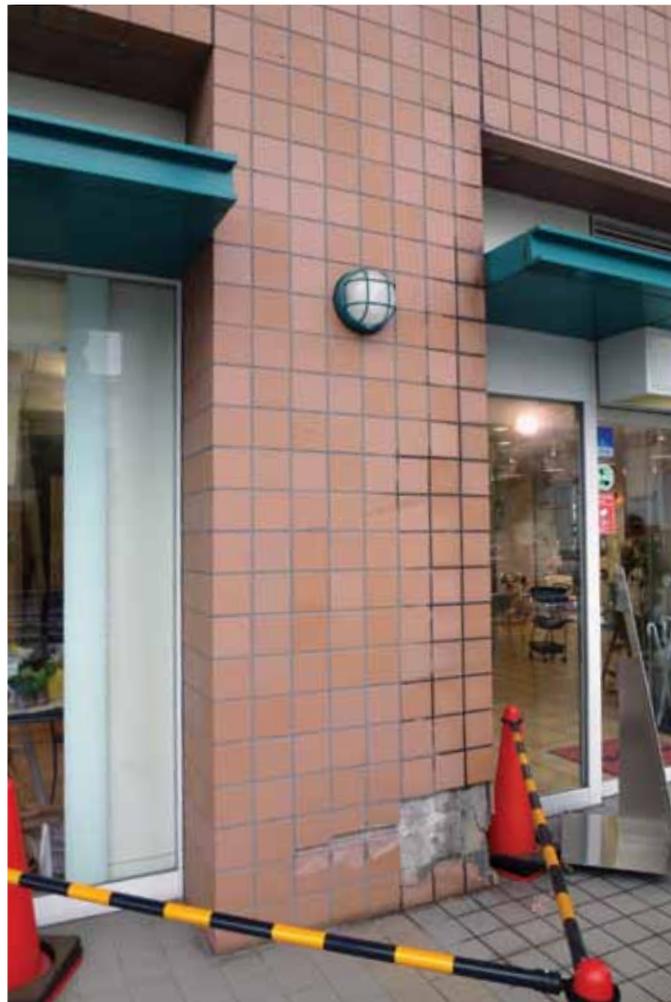
Figure 5. Minor spalling at the base of the columns of Namagachi Lions Tower.

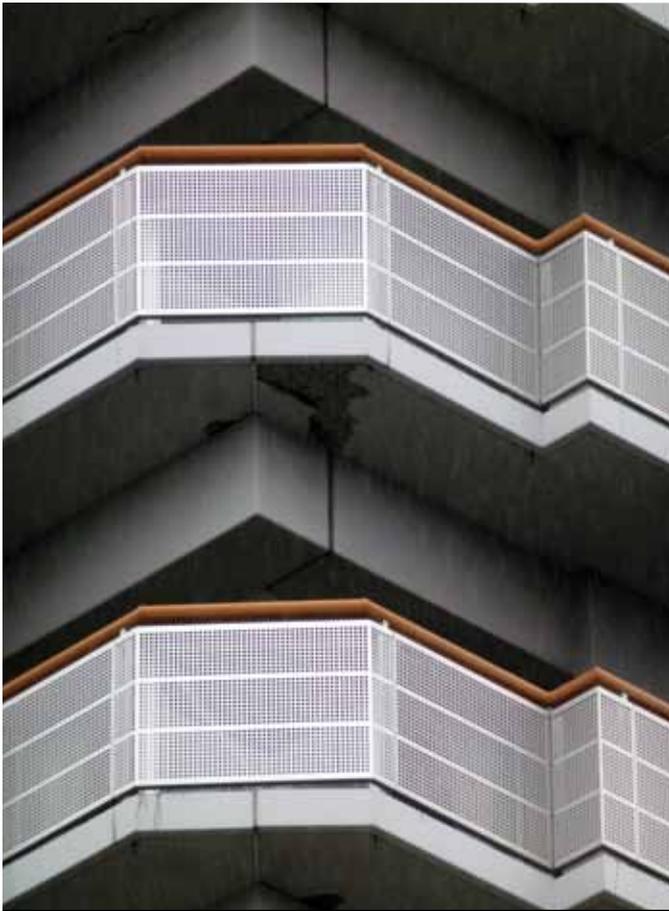
Figure 6. Spalling of slabs at corners of Namagachi Lions Tower.

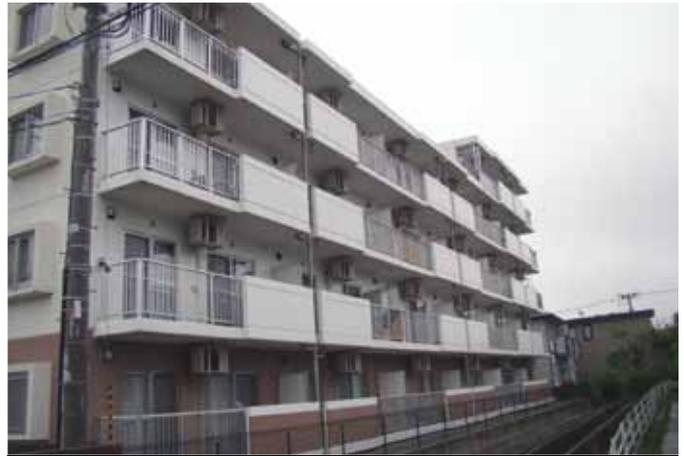
The four-story total-precaster concrete residential apartment building shown in **Fig. 7** was constructed in Natori City in 2006. The building has shear walls to provide earthquake resistance. Viewed from the exterior, the building appeared to have no structural damage or distress. Similar apartment buildings in the Kobe and Osaka area performed well in the 1995 Kobe earthquake.⁸

Figure 7. Three-story total-precaster concrete apartment building at Natori City.
