Distress Due to Sun Camber in a Long-Span Roof of a Parking Garage

by Mark Fintel and S. K. Ghosh

Distress in a 9-story cast-in-place concrete parking garage is described. A detailed account is given of field observations, measurements, and computations leading to a definite diagnosis for the distress. A repair procedure that accommodates unavoidable movements of the structure is outlined.

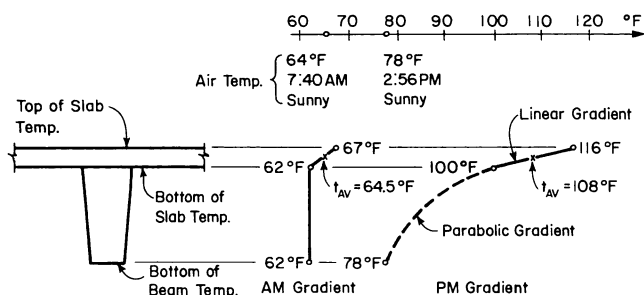
Fig. 6 — Sample of measured temperatures.

- Temperatures of the top and bottom of the 4-in. (102-mm) thick slab and the underside of the slab joists (Fig. 6), using a surface thermometer.

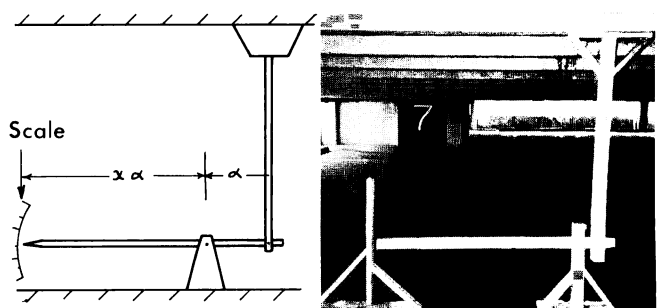
Fig. 7 — Deflection measuring device.

- Deflections of the 60 ft (18.3 m) slab spans using the device shown in Fig. 7, which magnified slab deflections by 11.33.
- Crack widths in the exterior columns under the slab using an optical instrument with a magnification ratio of 50.
- Ambient temperatures and the corresponding weather conditions.

The plot in Fig. 10b shows the measured differential upward slab deflections (sun camber) between the mornings and afternoons. The measurements were taken using the device shown in Fig. 7. A shortcoming of this measuring arrangement might be that the slab below the one whose deflections were being measured could also be undergoing some thermal deflections.

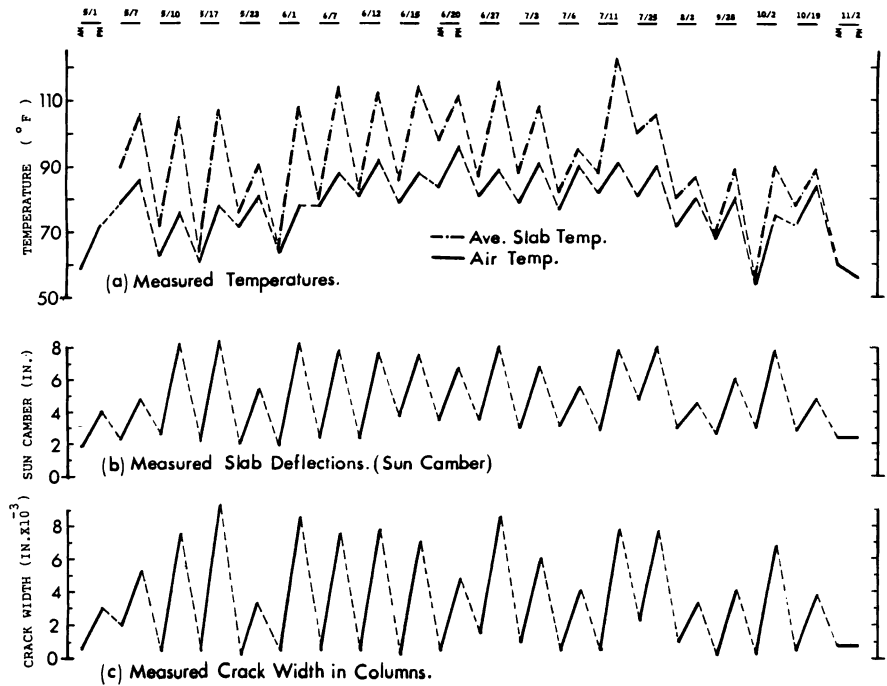
Fig. 8 — Plots of measured temperatures, sun camber, and crack widths.

Table 1 is a summary of the recorded data. Fig. 8 shows plots of the 20 diurnal recordings of air temperatures, sun camber, crack widths in columns, and the computed average temperatures of the slab.

The plot in Fig. 8a of the ambient temperatures and average slab temperatures shows very definitely the effect of direct solar radiation. In all twenty cases (except for the rainy day of November 2) the slab temperatures were to various degrees higher than the ambient temperatures. For example, on the clear sunny day of July 11, the top of the slab reached 130 F (54.4 C), was 39 F (21.7 C) hotter than the ambient temperature of 91 F (32.8 C) and was hotter than the bottom of the slab by 15 F (8.3 C). On this afternoon, the average slab temperature rose by 30.8 F (17.1 C) over that at 8:30 A.M., causing an increase in the sun camber of 0.43 in. (10.9 mm). During the same time the ambient temperatures rose by only 9 F (5 C).

Inspecting the plots in Figs. 8a, b, and c, for average slab temperatures, the sun camber, and crack width, respectively, it is evident that they are almost identical in their shapes. This indicates that, over the observed temperature range, the sun camber of the slab and the rotation of the spandrel beams were directly proportional to the factor causing them: a temperature gradient through the slab and beam. The results also lend confidence to the accuracy of the performed measurements.

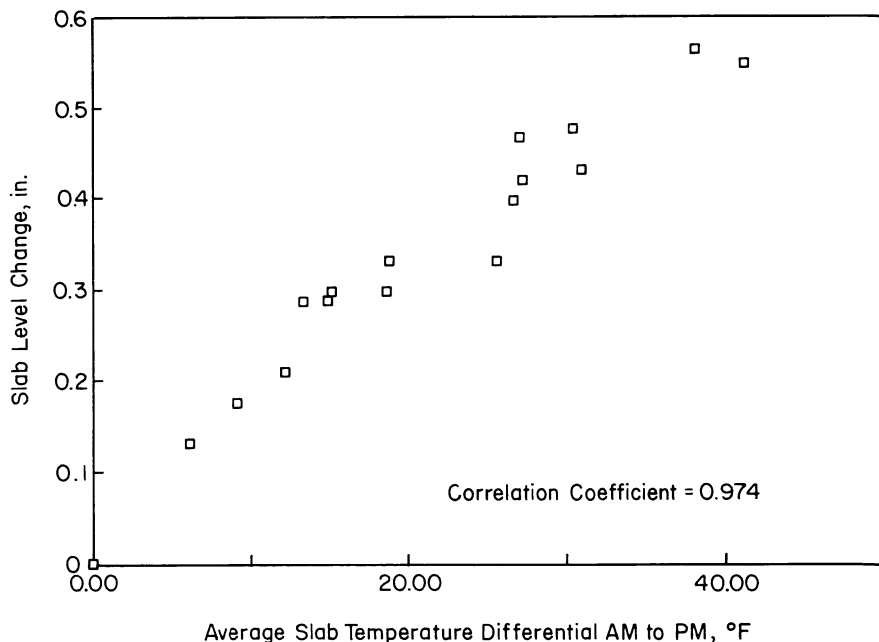
Fig. 10 — Plot of average slab temperature change vs. slab level change.

Column 9 of Table 1 shows the computed average temperatures across the slab section (including beam); column 10 shows the difference between the respective morning and afternoon slab temperatures; column 13 shows the corresponding differentials in slab levels. The average slab temperature change (morning to afternoon) to slab level change relationship is graphically presented in Fig. 10. A regression analysis of the 17 sets of data showed a correlation coefficient of 0.974.

It is evident from the plot that the differentials of the slab temperature rose less on cloudy days. At the other extreme, the average slab temperature increased by only 6 F (3.3 C) on the rainy afternoon of August 3 (relative to the morning) while the air temperature increased by 8 F (4.4 C) during the same period. Also, the top of the slab was cooler than the bottom by 3 F (1.7 C) (this could be attributed to evaporative cooling).

In Fig. 10c, crack widths in columns measured at locations shown in Fig. 5 are plotted. The crack widths are averages of measurements made on Columns G6, J6, P6 and R1.
